Subject: September 21, 2009, Compliance Evaluation Inspection - Asarco East Helena Plant

FIELD INVESTIGATION REPORT

SITE: Asarco - East Helena Facility

PURPOSE: Compliance Evaluation Inspection

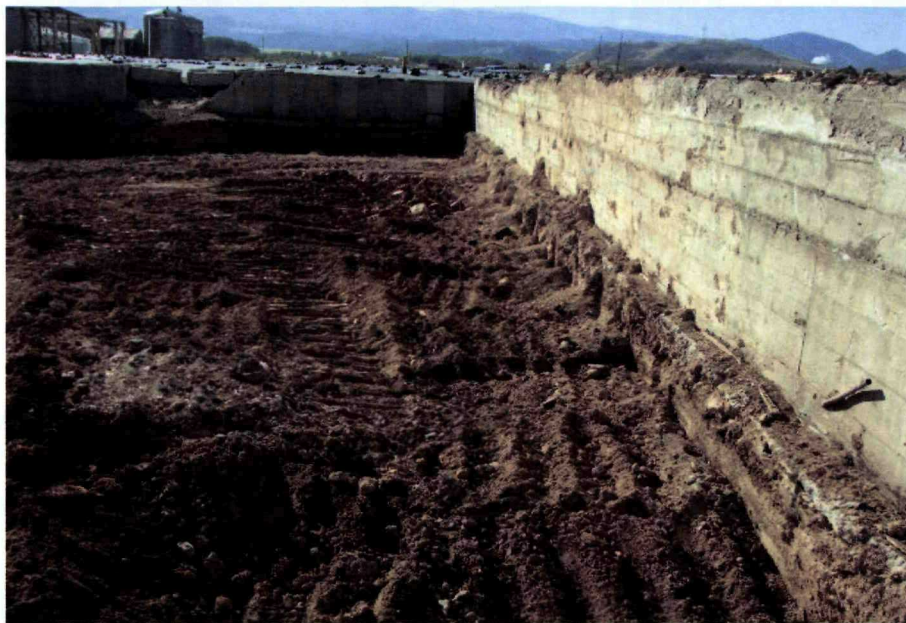
Looking southeast, this photo shows the Sample Mill basement after demolition. The basement area will be backfilled with fumed slag to achieve proper drainage in the Sample Mill footprint.

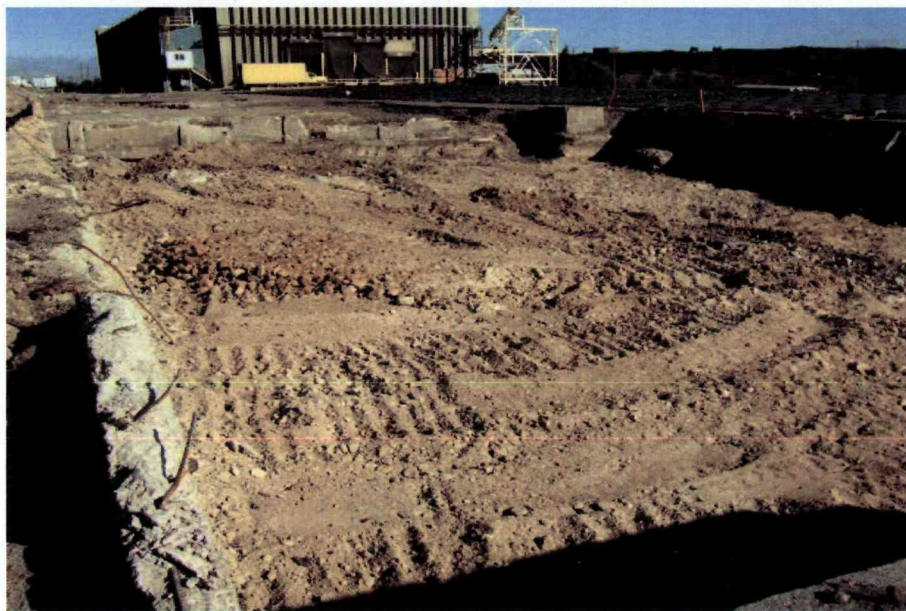
PHOTO #: ASARCO_09264-002
DATE: September 21, 2009
PHOTOGRAPHER: Iver L. Johnson
PHOTOGRAPHER (int.) *I*
CAMERA: Fujifilm Finepix F40 Digital Camera
FILM TYPE: N/A
NEGATIVE LOCATION: N/A
EXPLANATION:

Another view of the Sample Mill basement with the CSHB in the background.

After the basement is filled in with fumed slag, the concrete walls will be demolished to grade. The footprint will then be covered with fabric to allow for storm water run-off.

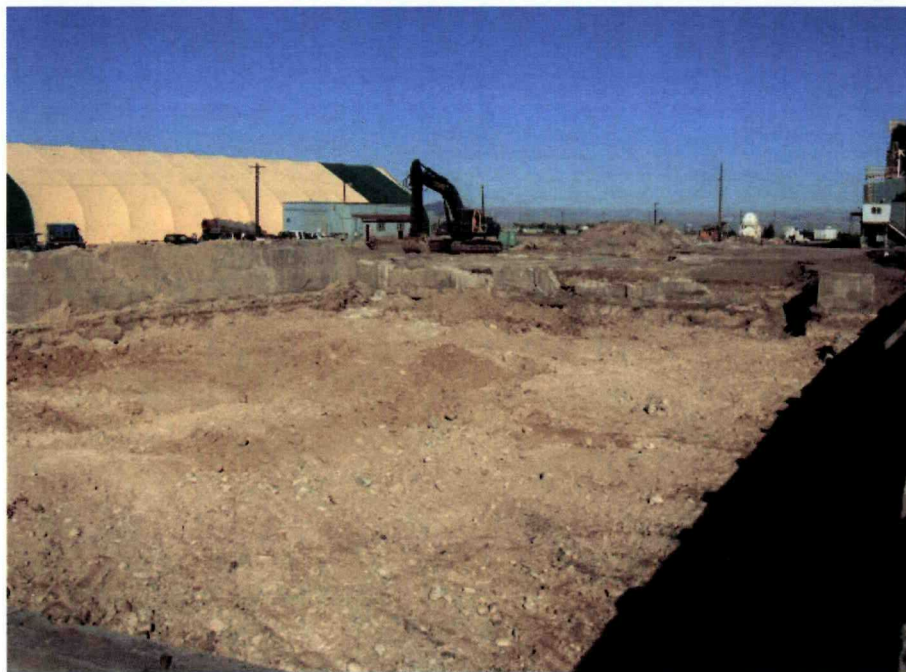
PHOTO #: ASARCO_09264-003
DATE: September 21, 2009
PHOTOGRAPHER: Iver L. Johnson
PHOTOGRAPHER (int.) *I*
CAMERA: Fujifilm Finepix F40 Digital Camera
FILM TYPE: N/A
NEGATIVE LOCATION: N/A
EXPLANATION:

Another photo of the Sample Mill footprint prior to Fumed slag backfill.

Excess soil was removed from the Sample Mill basement prior to the collection of the exposed demolition soil samples.

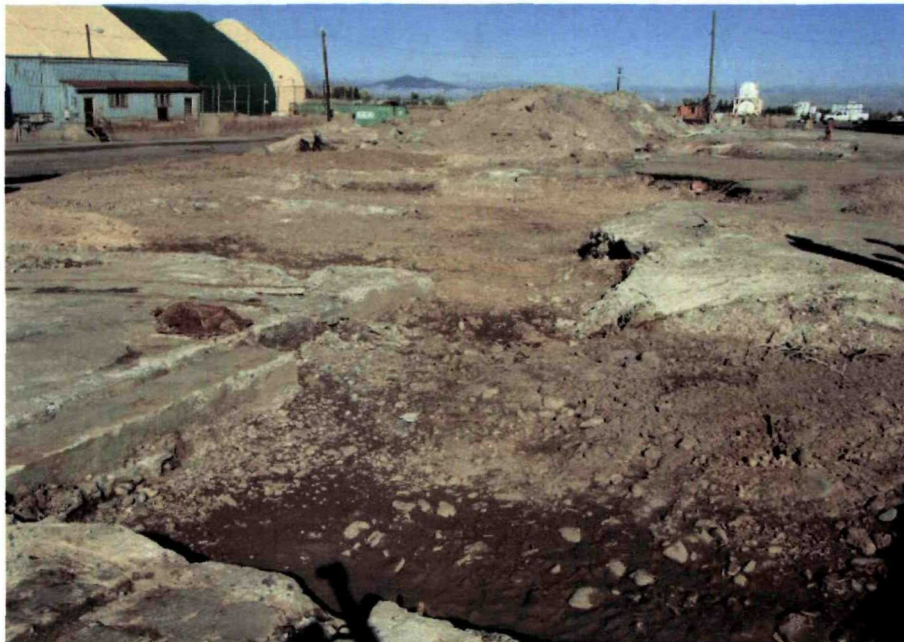
PHOTO #: ASARCO_09264-004
DATE: September 21, 2009

Just to the northwest of the former Sample Mill, this photo shows the footprint of the former Dust Load Out Baghouse area.

This area will be filled in with fumed slag, covered with fabric, brought to grade, and sloped to allow for storm water run-off.

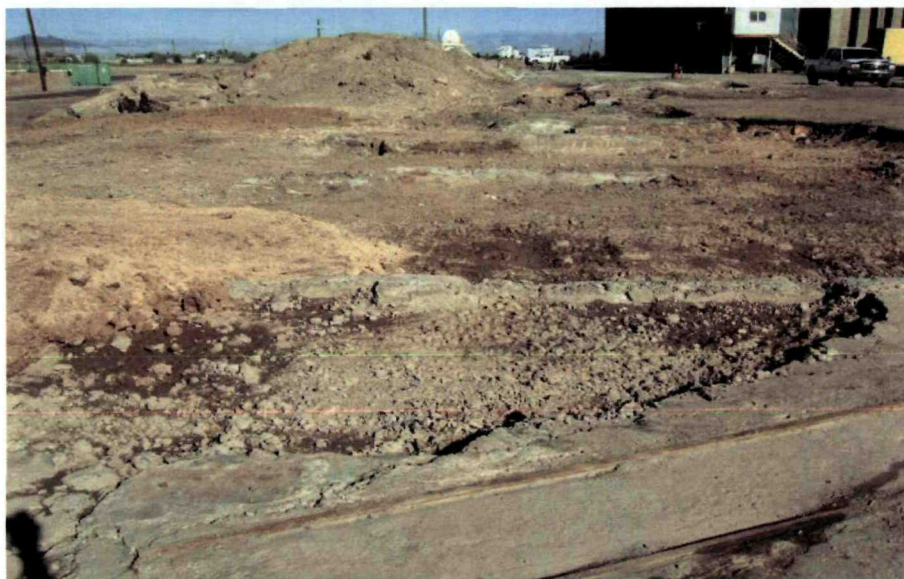
PHOTO #: ASARCO_09264-005
DATE: September 21, 2009

Another photo of the Dust Load Out Baghouse area footprint and former location of the Crushing Mill prior to fumed slag backfill.

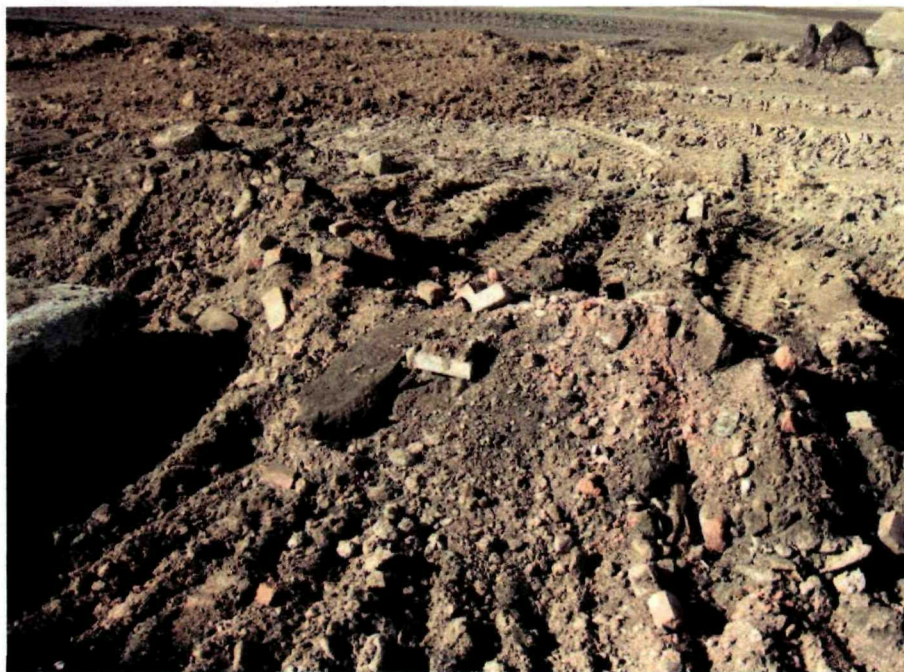
PHOTO #: ASARCO_09264-006
DATE: September 21, 2009

This photo shows the viewer all that remains of the Crushing Mill feed hopper location.

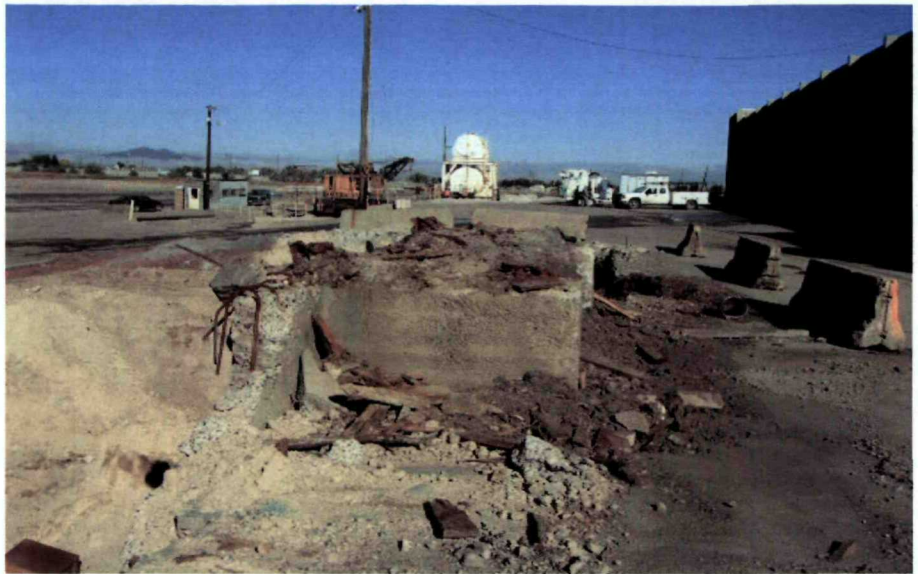
PHOTO #: ASARCO_09264-007
DATE: September 21, 2009

Looking northwest towards the Scale House, this photo shows the footprint of the Crushing Mill basement after demolition.

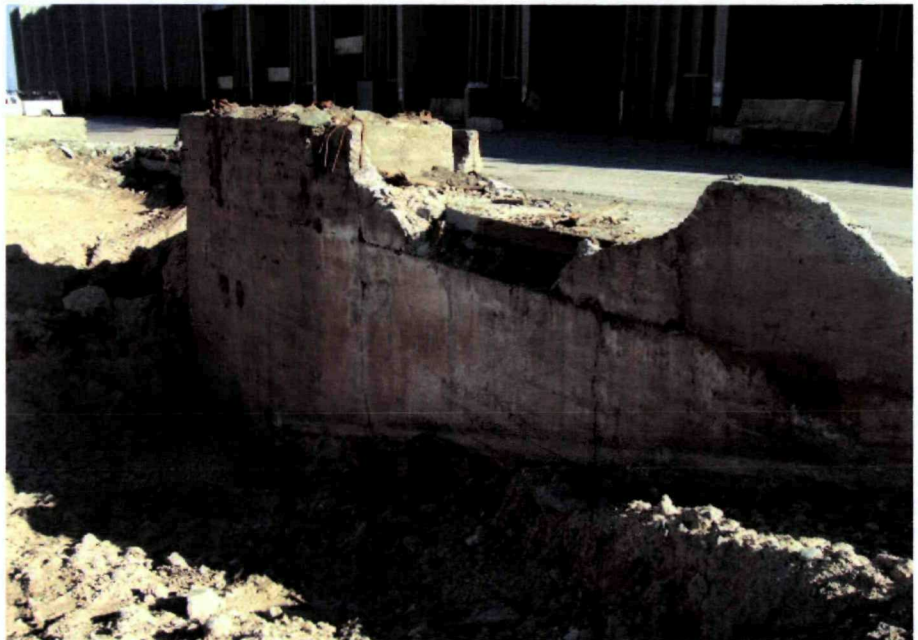
PHOTO #: ASARCO_09264-008
DATE: September 21, 2009

Excess soil was removed from the Crushing Mill Basement prior to the collection of the exposed demolition soil samples.

The Crushing Mill basement will be filled in with fumed slag. After that, the support walls, as shown in this photo, will be demolished to grade and the footprint covered with fabric to allow for storm water run-off.

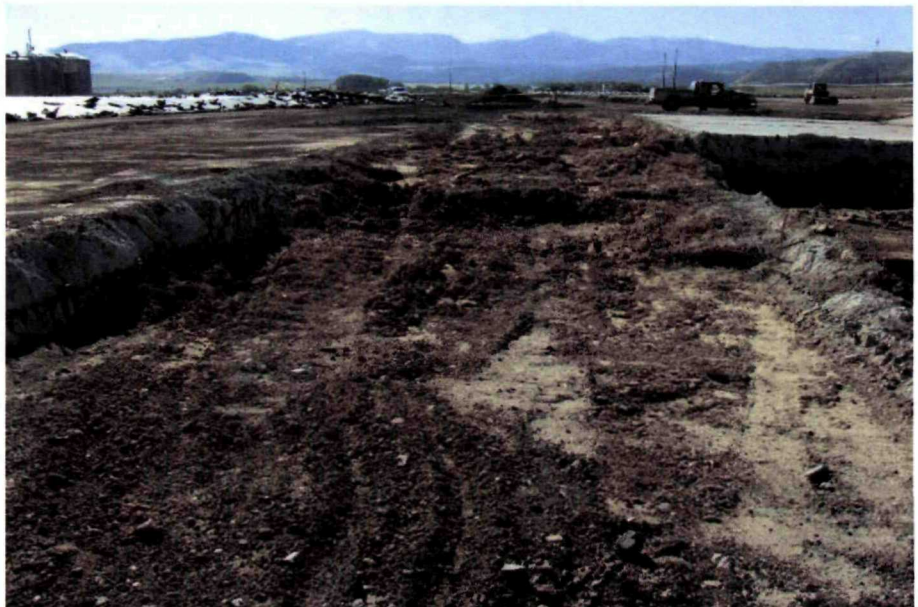
PHOTO #: ASARCO_09264-009
DATE: September 21, 2009

Looking southeast, at another photo of the former Crushing and Sample Mill footprints prior to fumed slag backfill.

The former Hopto Pad and Bin location is the concrete area located just in front of the pick-up truck that sits in the background.

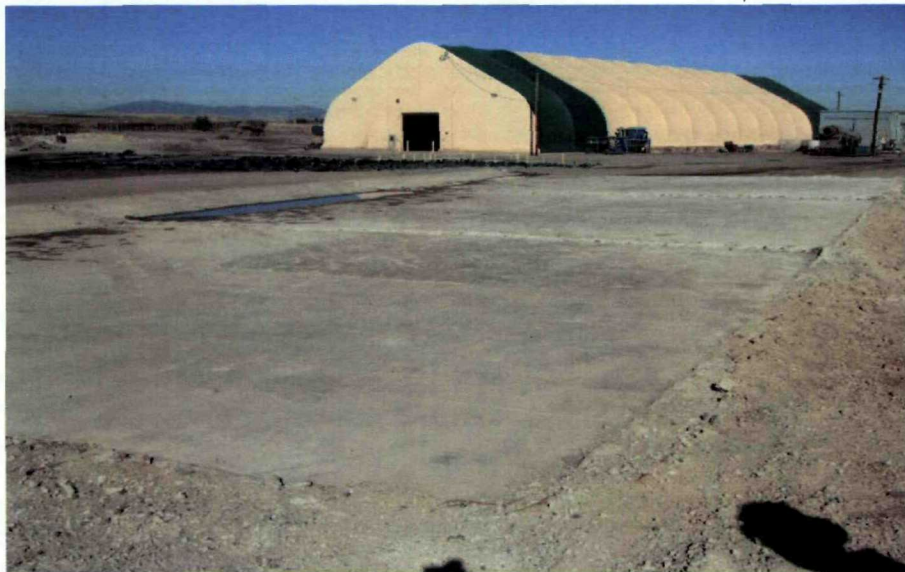
PHOTO #: ASARCO_09264-010
DATE: September 21, 2009

Looking southwest, this photo shows the former location of the Hopto pad and storage bins.

Note: All the storage bins walls were removed to grade level. In addition, all protruding rebar was removed to grade.

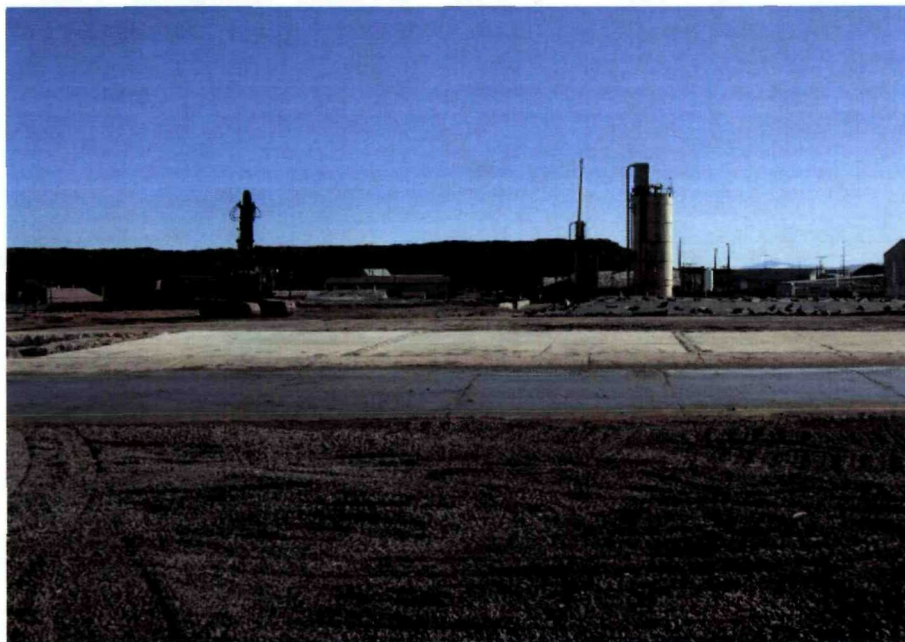
PHOTO #: ASARCO_09264-011
DATE: September 21, 2009

Another photo of the Hopto Pad footprint. The pad will not be covered with fabric.

The areas in and around the Hopto unloading facility will be contoured with fumed slag.

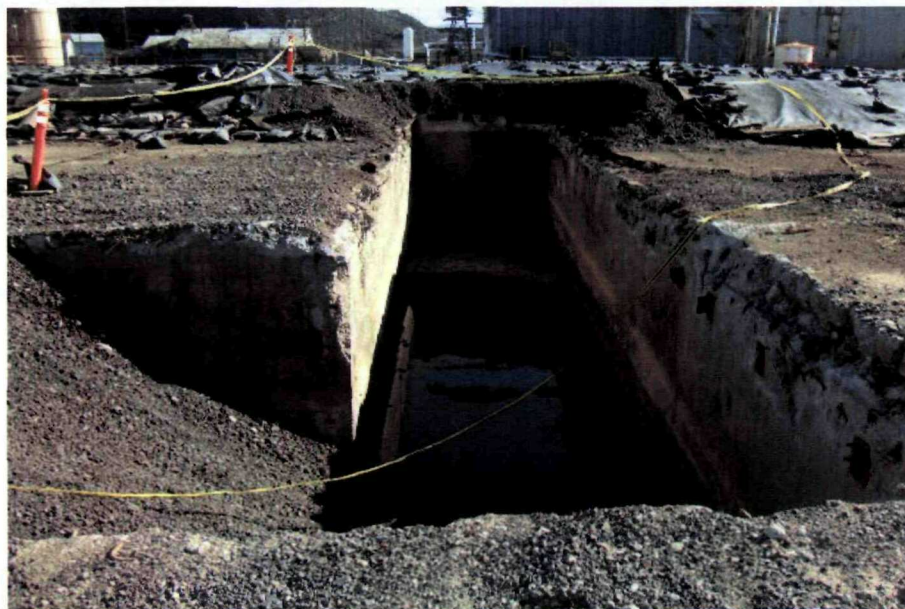
PHOTO #: ASARCO_09264-012
DATE: September 21, 2009

This photo shows the Hopto Conveyor Gallery that moved material to the Direct Smelt Building.

The gallery basement will be filled in with fumed slag and brought to grade to allow for storm water run-off.

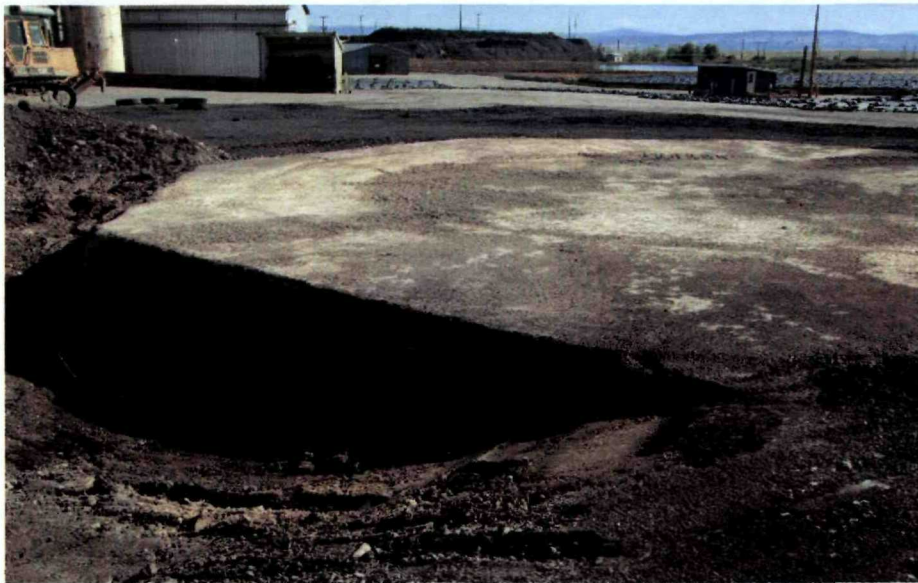
PHOTO #: ASARCO_09264-013

Acid Plant Stack & Base: Demolished and Cleaned. The Acid Plant Stack was demolished on August 14, 2009. All the mortar used to attach the stack to the concrete base was removed. The stack base was cleaned using standard mechanical methods and then flushed with water. Fumed slag will be spread in the low-lying areas around the stack base to create proper drainage. (Refer to photo 013 in the attached photolog.)

All that remains of the Acid Plant Stack is the base as shown in this photo.

Fumed slag will be spread in the low-lying areas around the stack base to create proper drainage.

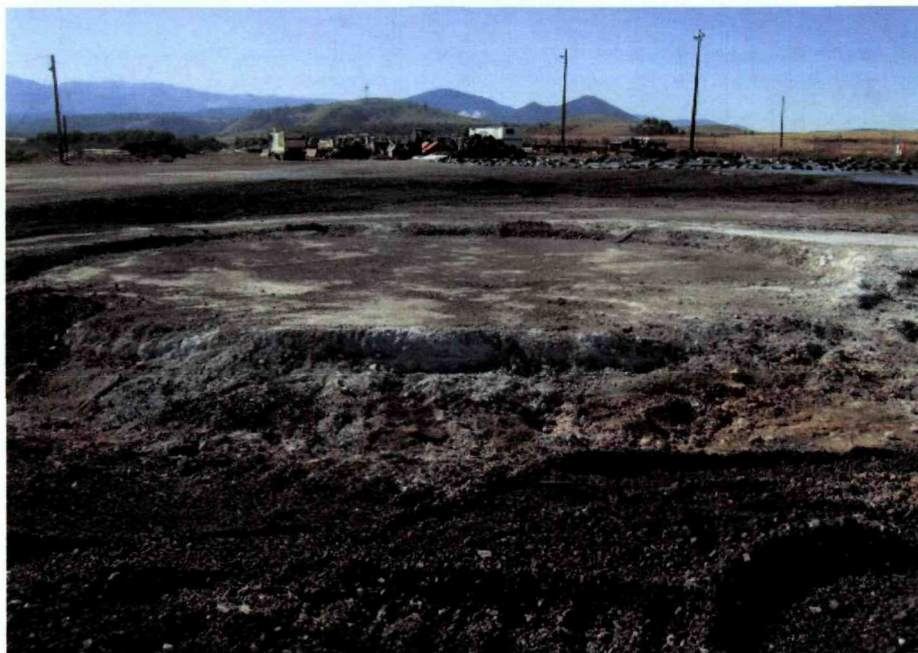
PHOTO #: ASARCO_09264-014

Sinter Plant Stack & Base: Demolished and Cleaned. The Sinter Plant Stack was demolished on August 14, 2009. All the rebar was cut flush from the stack base. The impact from the Sinter Plant stack created an elongated crater that crushed both the existing concrete pad and surround soils. The stack base was cleaned using standard mechanical methods and then flushed with water. (Refer to photo 014 in the attached photolog.)

All that remains of the Sinter Plant stack is the base as shown in this photo.

Fumed slag will be spread in the low-lying areas around the stack base to create proper drainage.

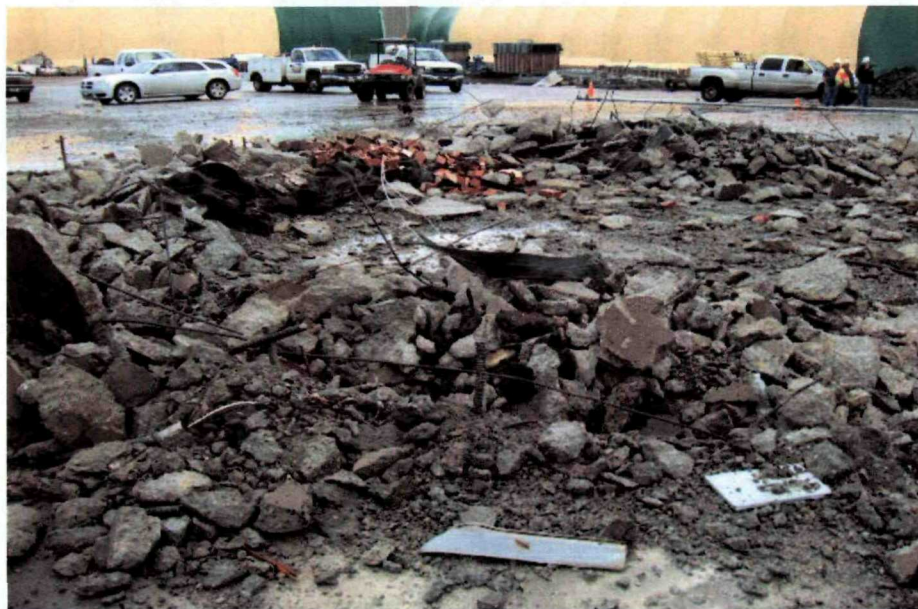
PHOTO #: ASARCO_09264-015

Blast Furnace Stack & Base: Demolished. The Blast Furnace Stack was demolished on August 14, 2009. All the rebar was cut flush from the stack base. The Blast Furnace Stack base contained minimal amounts of adhered ACM mastic that could only be removed after the stack was demolished. The mastic and associated concrete containing the ACM was placed in the designated area of the CAMU cell. (Refer to photo 015 in the attached photolog.)

This photo shows the Blast Furnace Stack Base shortly after demolition. The Blast Furnace Stack base contained minimal amounts of adhered ACM mastic that could only be removed after the stack was demolished.

All the stack debris was removed to the CAMU after this inspection was completed.

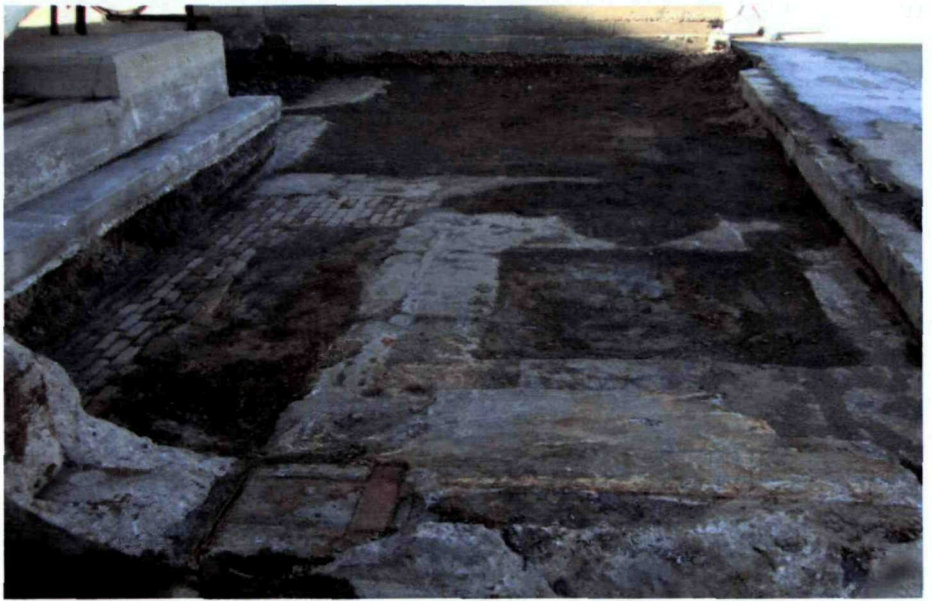
PHOTO #: ASARCO_09264-016
DATE: September 21, 2009

This photo shows the footprint of the former Material Staging and Processing area that lies just to the west and south of the Direct Smelt Building.

The footprint will be filled in with fumed slag and covered with fabric.

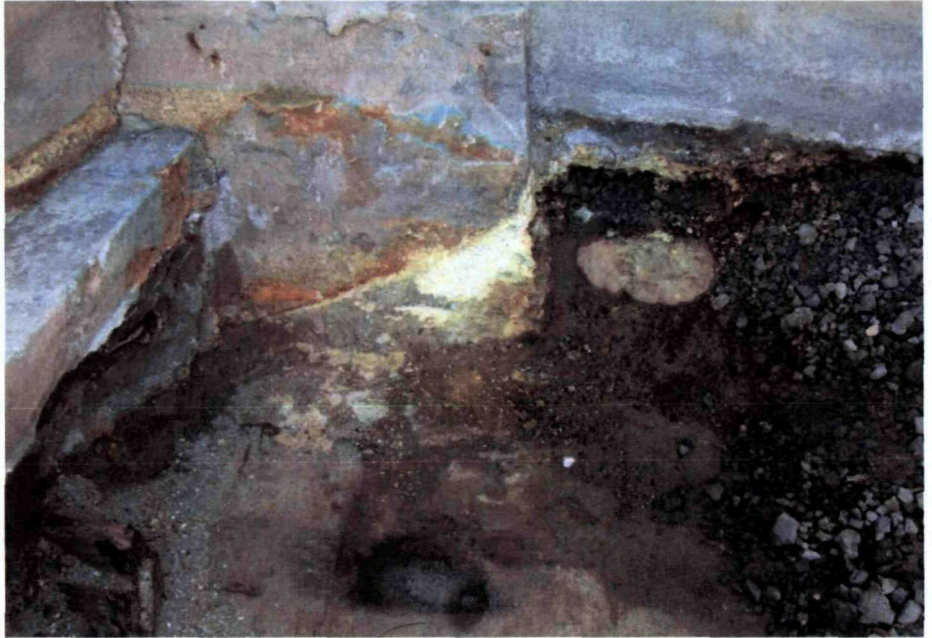
PHOTO #: ASARCO_09264-017
DATE: September 21, 2009

Groundwater Sump Area: Demolished and Cleaned. The area in and around the Groundwater Sump Area footprint has been cleaned. However, a small amount of secondary material in one corner needed to be cleaned-up at the time of the inspection. (Refer to photos 016 and 017 in the attached photolog.)

Some minor clean-up of secondary material was still needed in the corners of the Highline area, as shown in this photo at the time of the inspection.

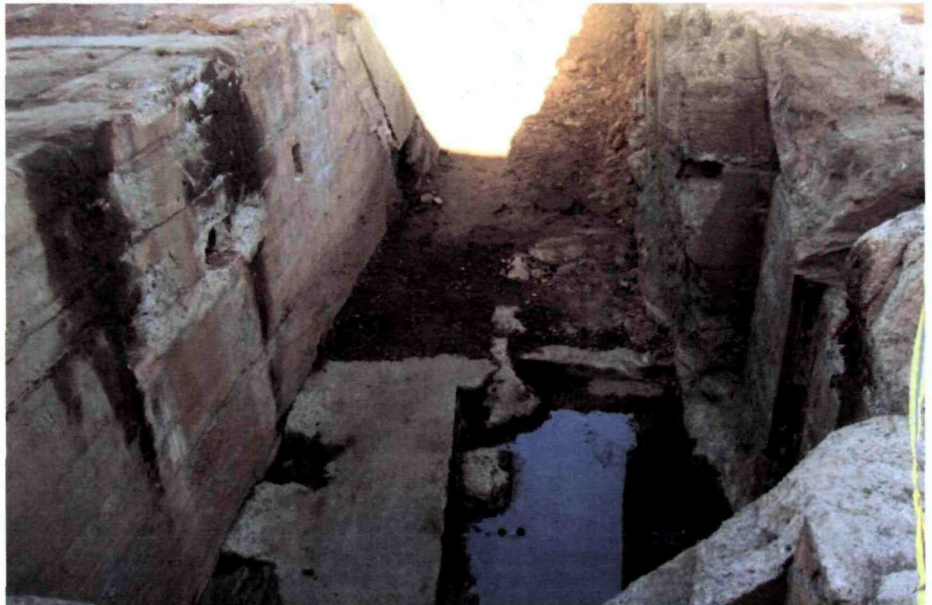
PHOTO #: ASARCO_09264-018
DATE: September 21, 2009

After removing the crusher in the Abandoned Breaking Floor, the hole, as shown in this photo, will be filled in with fumed slag and covered with fabric.

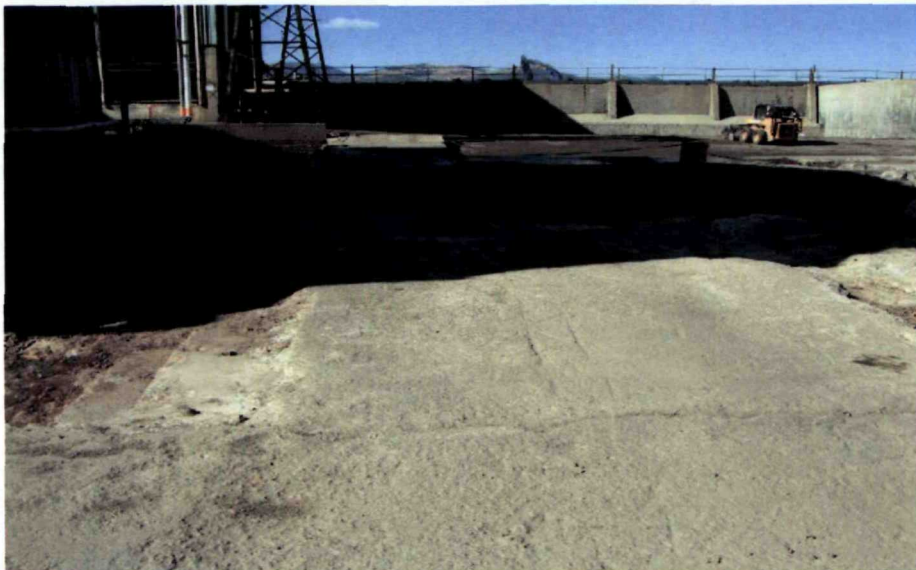
PHOTO #: ASARCO_09264-019
DATE: September 21, 2009

Looking at the footprint of the former Abandoned
Breaking Floor building entrance location.

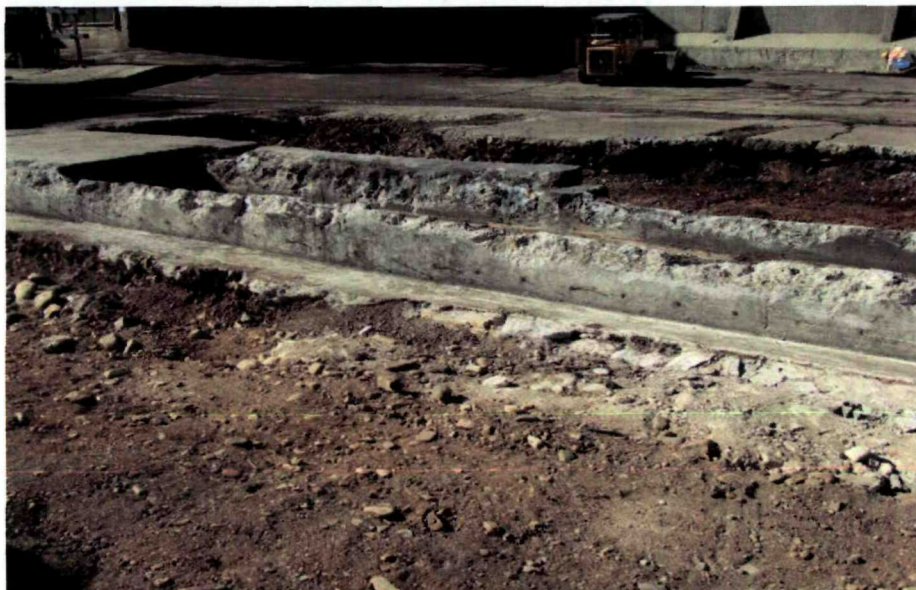
PHOTO #: ASARCO_09264-020
DATE: September 21, 2009

This photo shows the Coke storage area in the
background (with the front-end loader) and the
footprint of the Material Staging and Processing area in
the foreground.

All this area will be filled in with fumed slag and
covered with fabric to allow for storm water run-off.

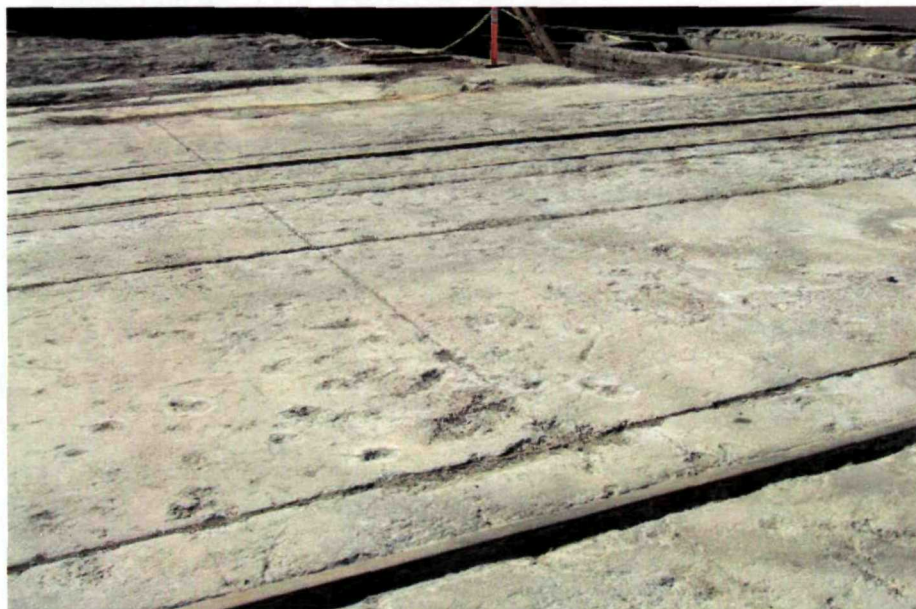
PHOTO #: ASARCO_09264-021
DATE: September 21, 2009

Looking at the footprint of the former New Breaking
Floor building location.

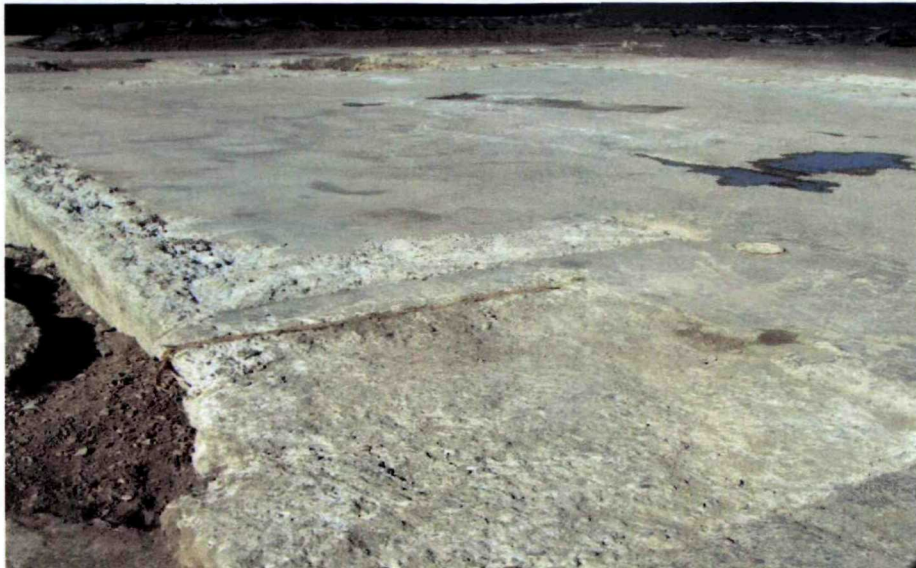
PHOTO #: ASARCO_09264-022
DATE: September 21, 2009

Looking at the footprint of the former Sinter Stockpile Building.

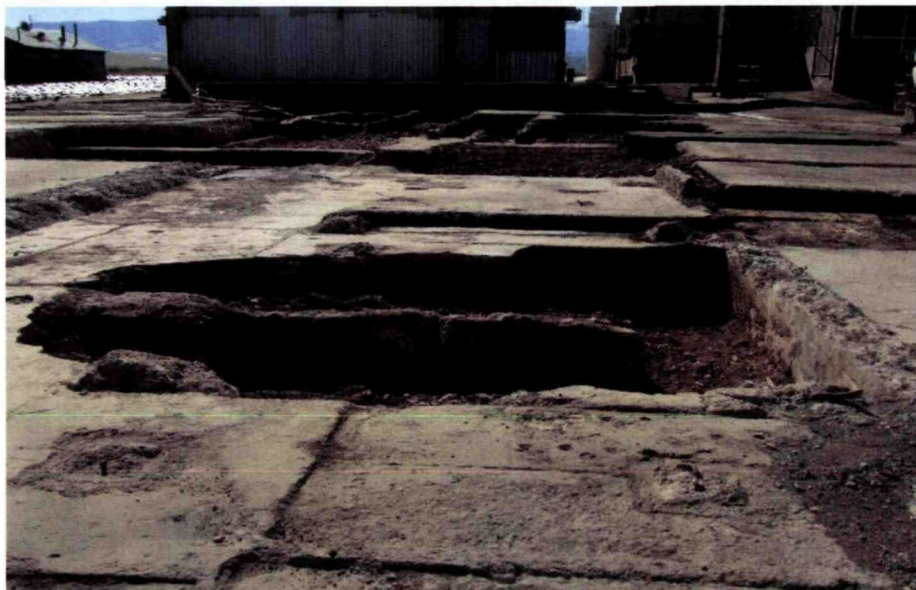
PHOTO #: ASARCO_09264-023
DATE: September 21, 2009

Looking east, with the Direct Smelt Building in the background, this photo shows the overall footprint of the Material Staging and Processing area.

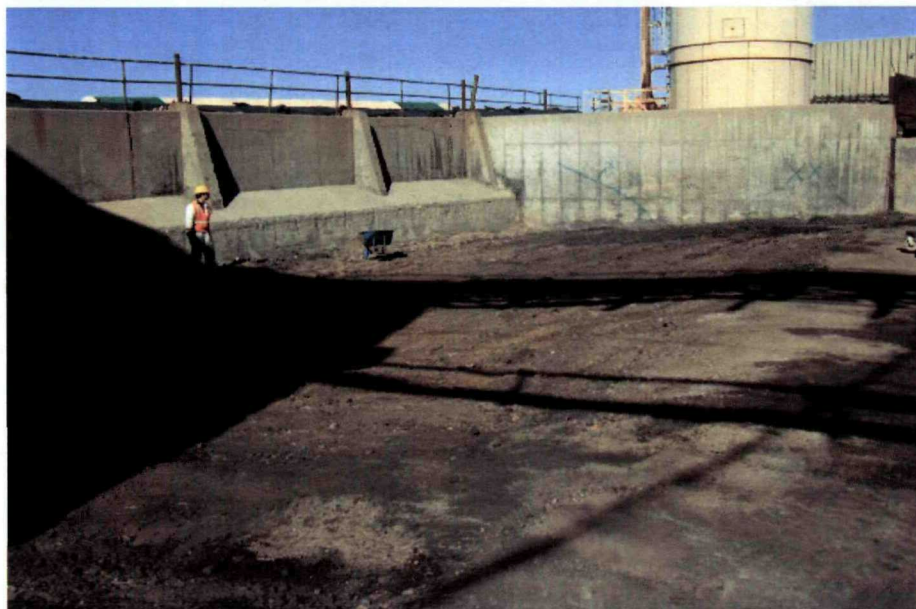
PHOTO #: ASARCO_09264-024
DATE: September 21, 2009

In addition, I observed Cleveland Wrecking Company personnel cleaning up debris in the former Coke Storage Area. After some discussion with Mr. Nickel, I told Mr. Nickel that I would talk to Ms. Linda Jacobson, EPA, and see if this area should be filled in with fumed slag and covered with fabric as well to facilitate storm water run-off. (Refer to photo 024 in the attached photolog.)

One more view of the former Coke storage area that lies to the southwest of the Direct Smelt Building.

This area will be filled in with fumed slag, graded, and covered with fabric to allow for storm water run-off.
